Examination of CPM[®] MagnaCut Blade Failed During Manufacture at Bark River

Requested by Bob Shabala
Niagara Specialty Metals

Report by: Gary Maddock

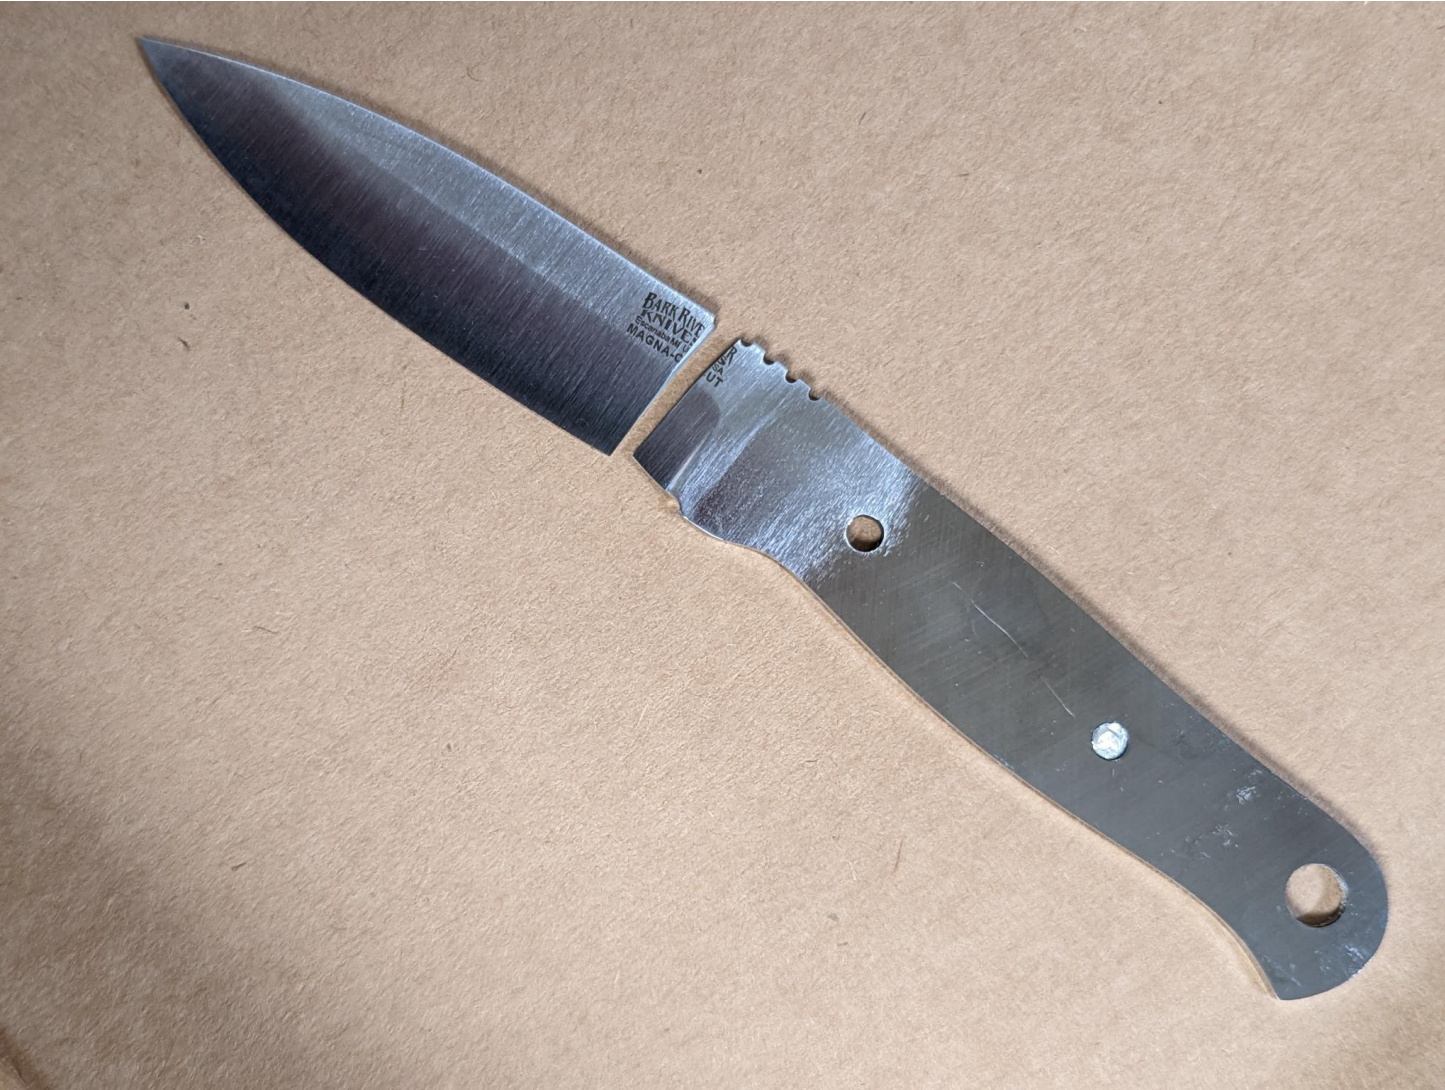
View of fractured blade as received for analysis

(blade exhibits primary ground bevel with unfinished edge)

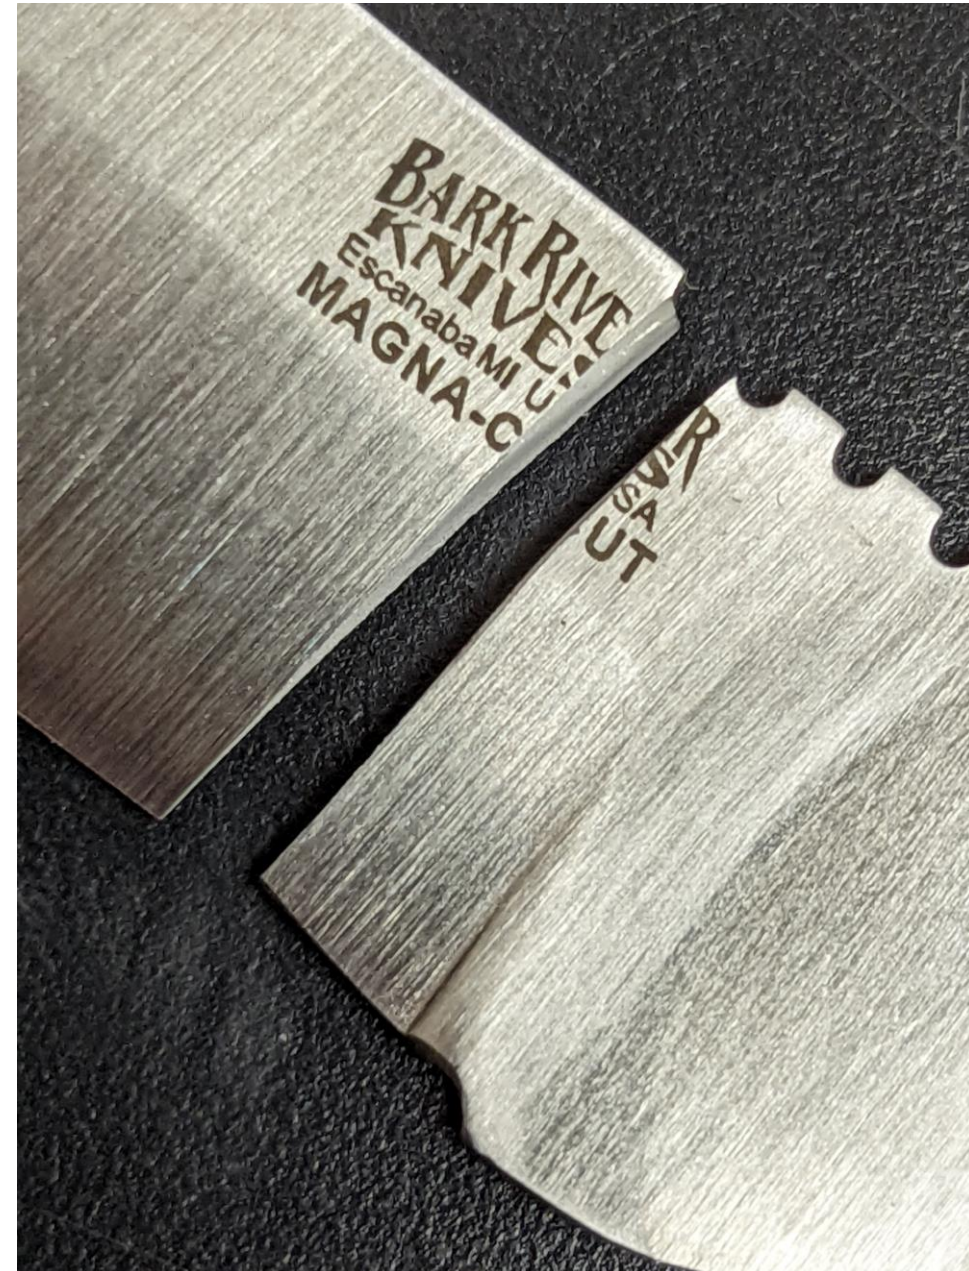
Close up of fracture:

- Blade surface is clean
- Fracture extends from jimping notch across blade in perpendicular fashion
- No evidence of mechanical damage on blade
- Macro hardness checks:
 - Blade- HRC 62.5-63
 - Handle- HRC 62.5-63

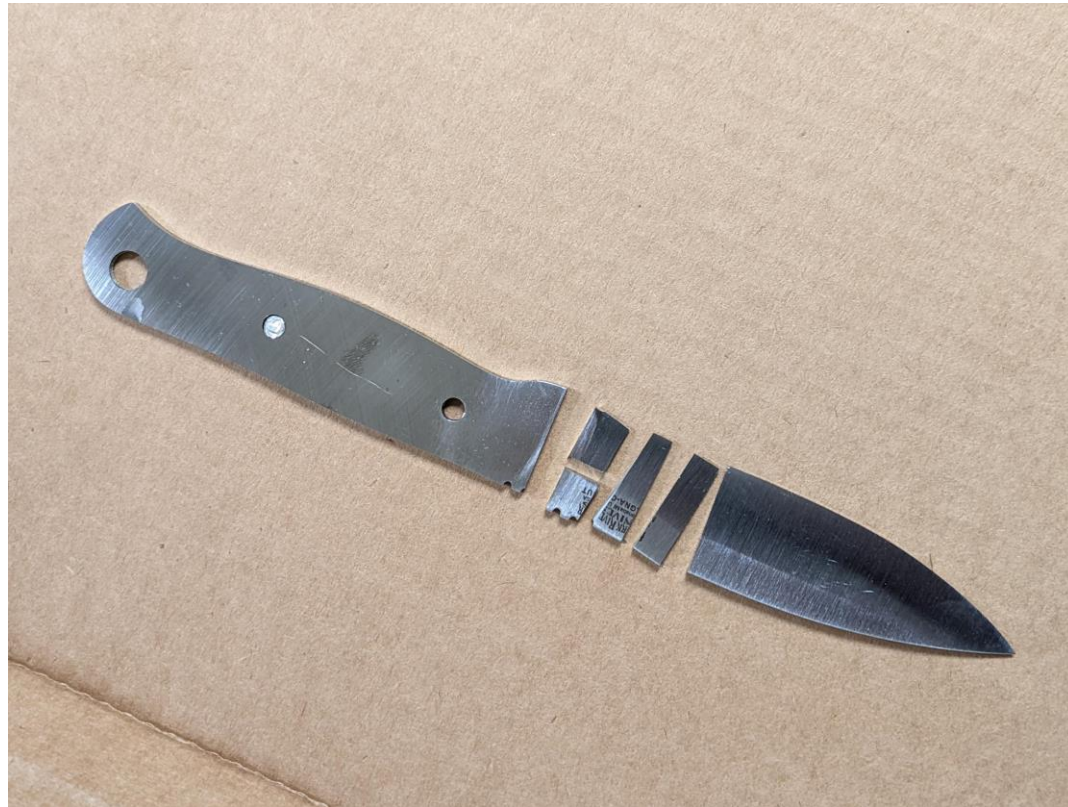
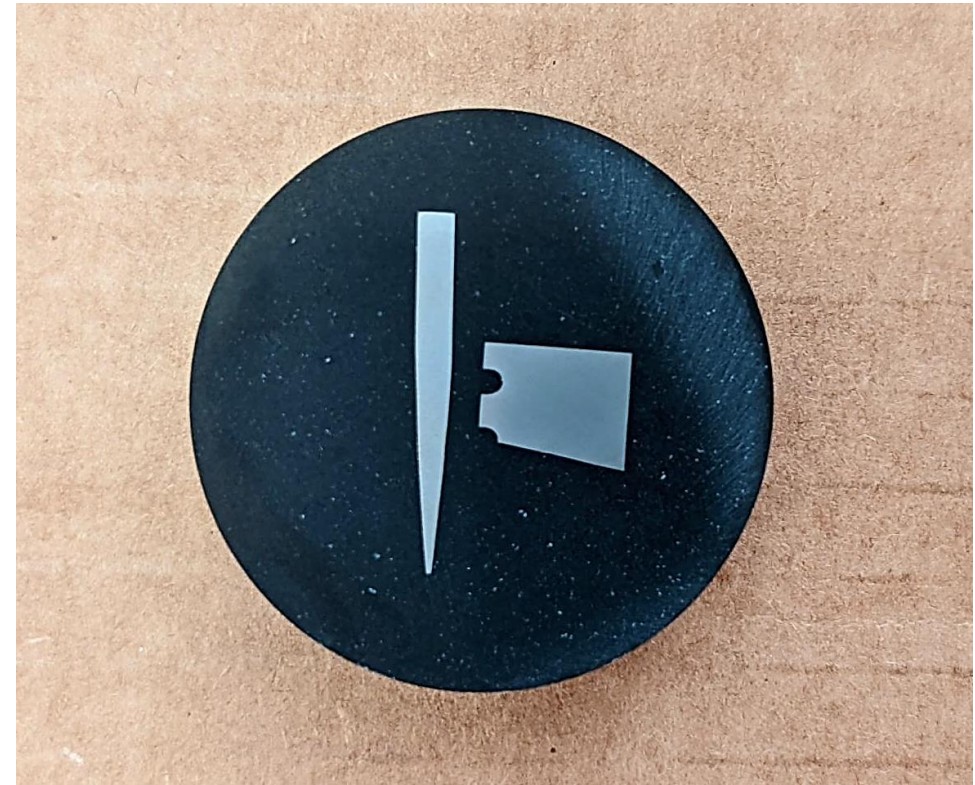
Specimen sectioned, mounted, and polished

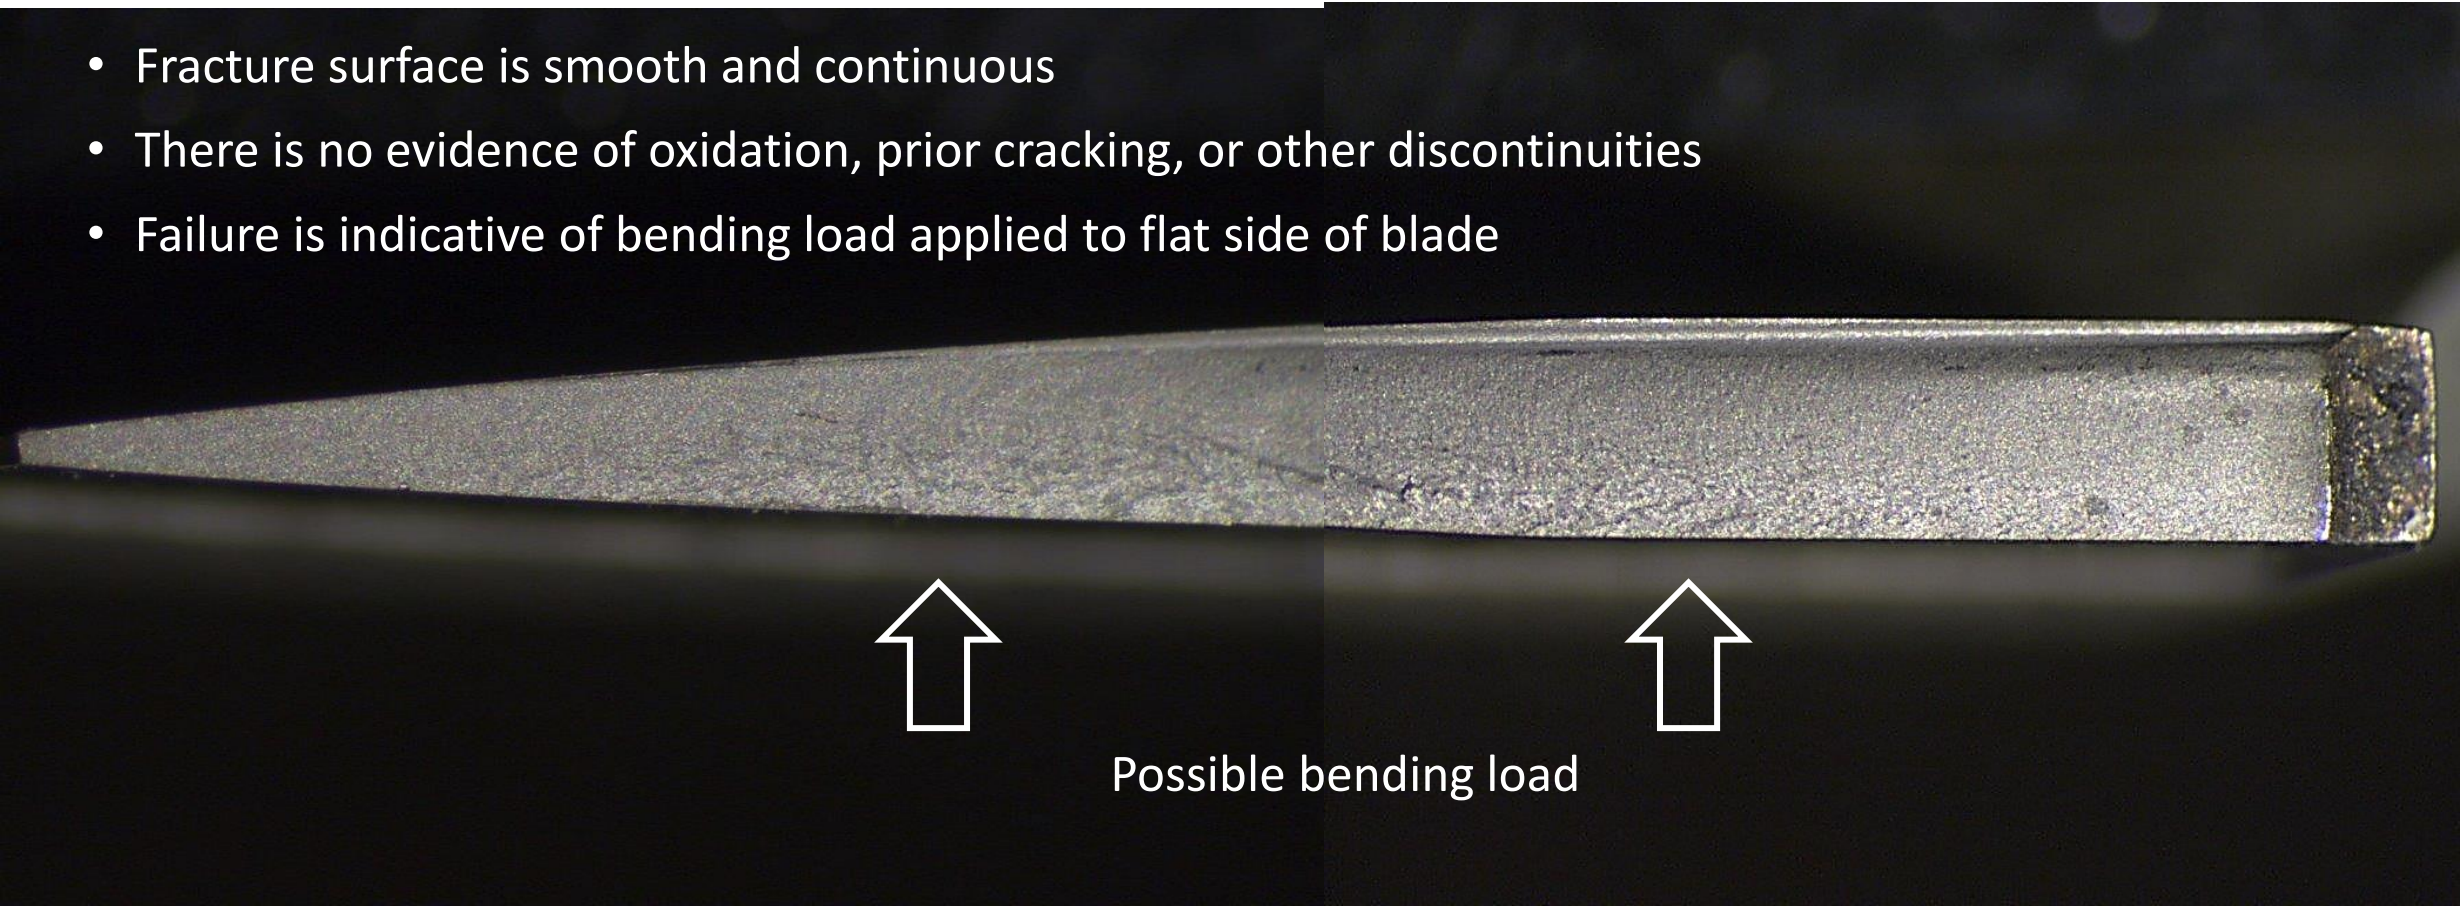
Composite view of fracture surface fracture.

- Fracture surface is smooth and continuous
- There is no evidence of oxidation, prior cracking, or other discontinuities
- Failure is indicative of bending load applied to flat side of blade

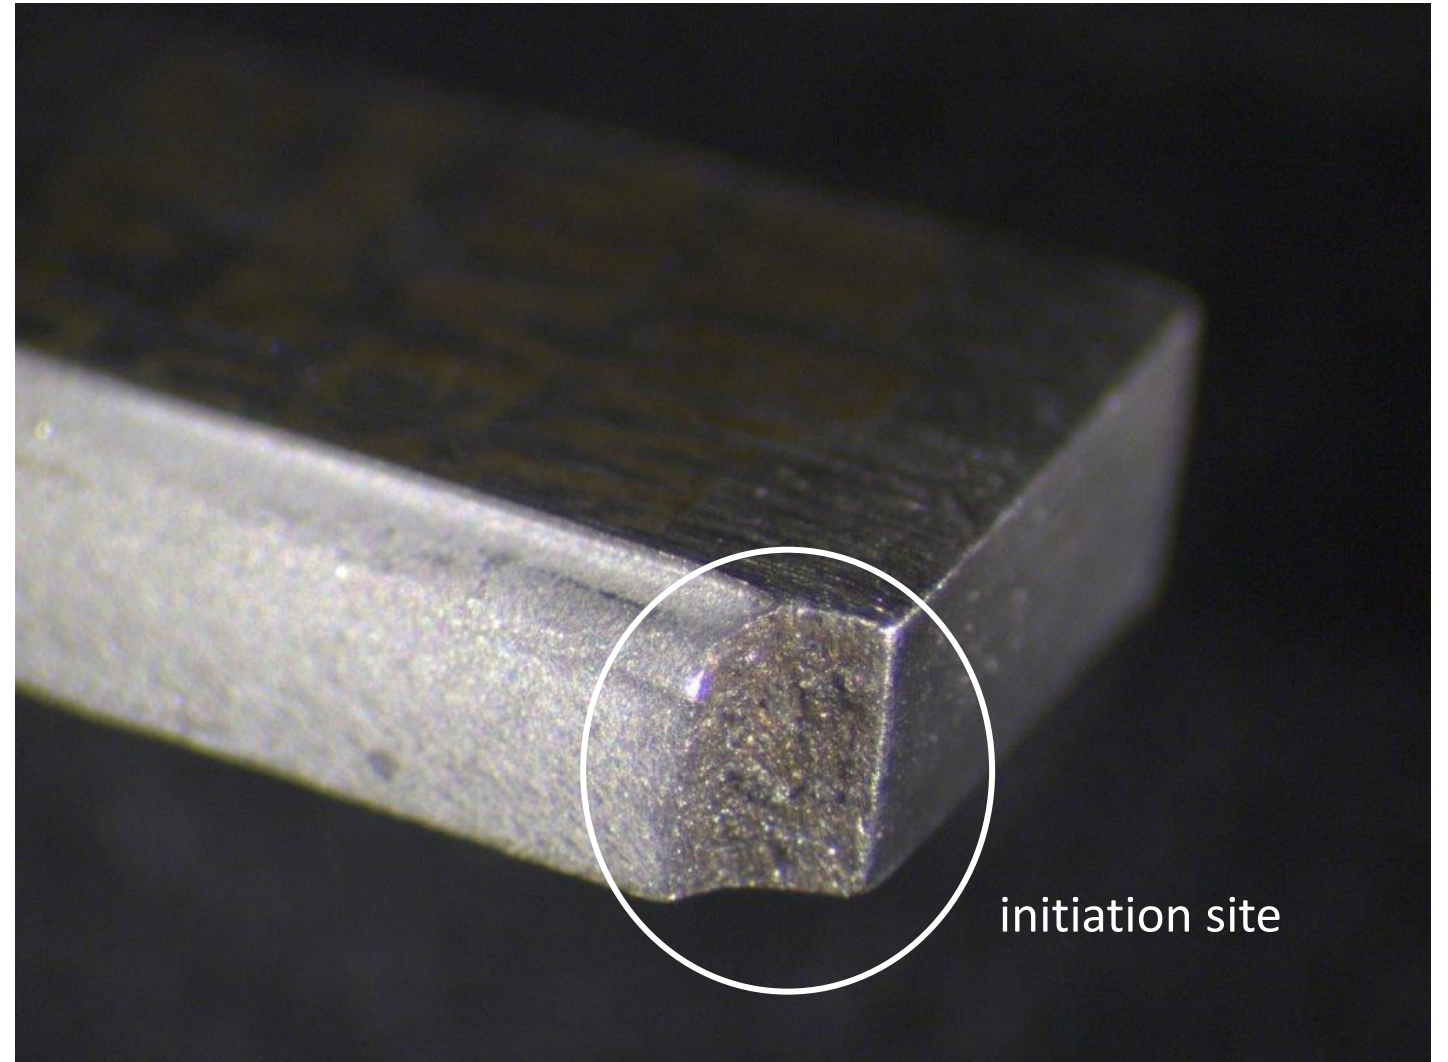
Macro view of corner:

- Rough surface evident within jimping notch
- Smooth fracture surface
- Bottom edge likely crack initiation site

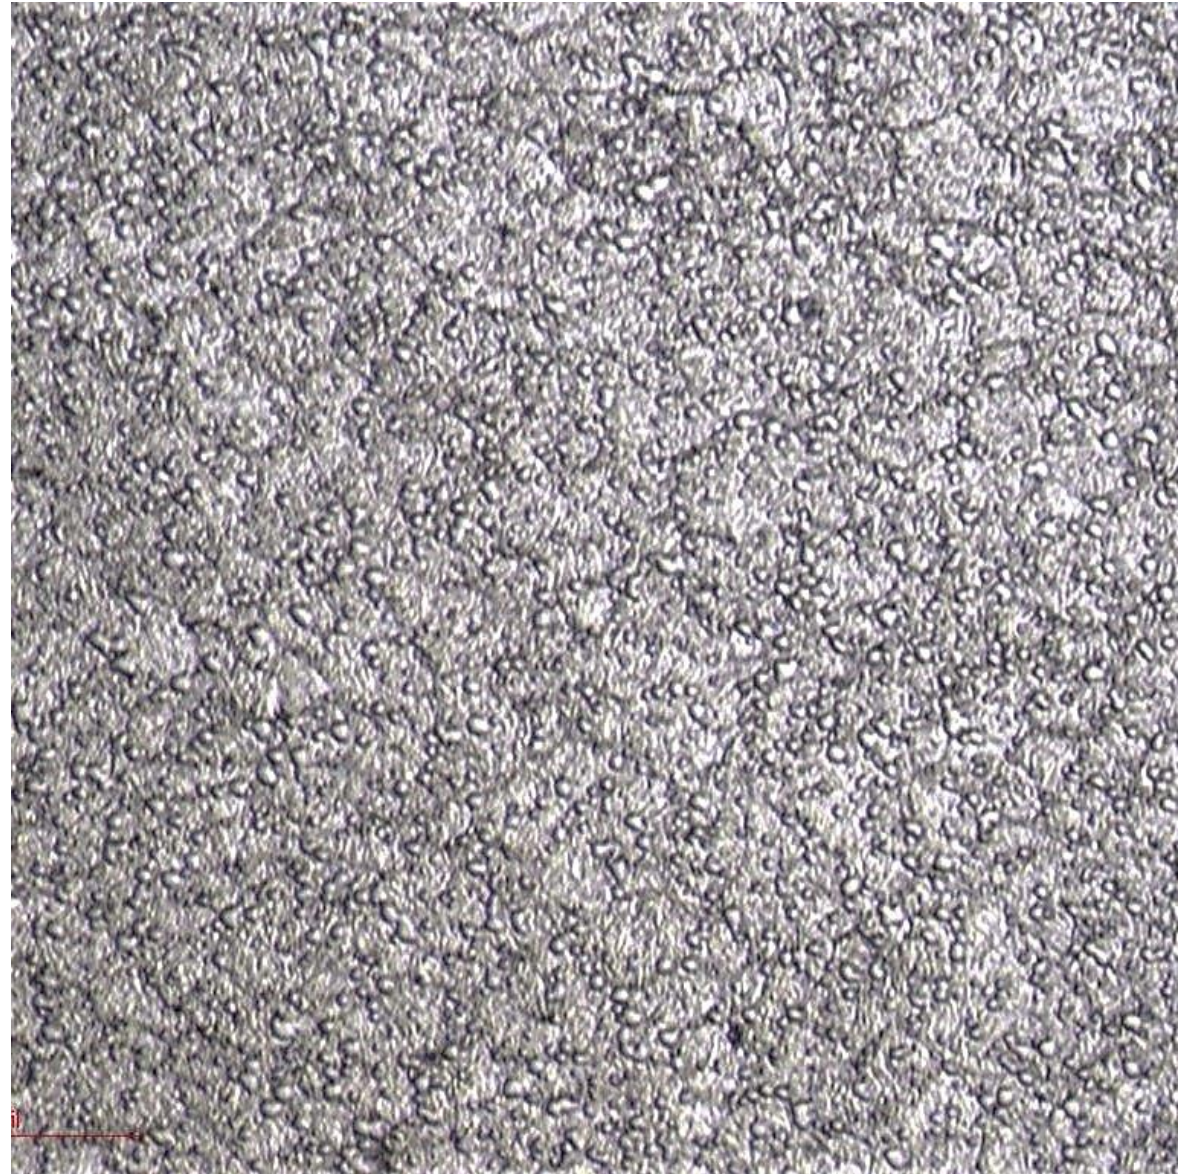
1000X Vilella's Etch

General Microstructure

- Uniform dispersion of very fine carbide as expected for CPM MagnaCut Alloy
- No evidence of material defects
- Appears properly hardened and tempered

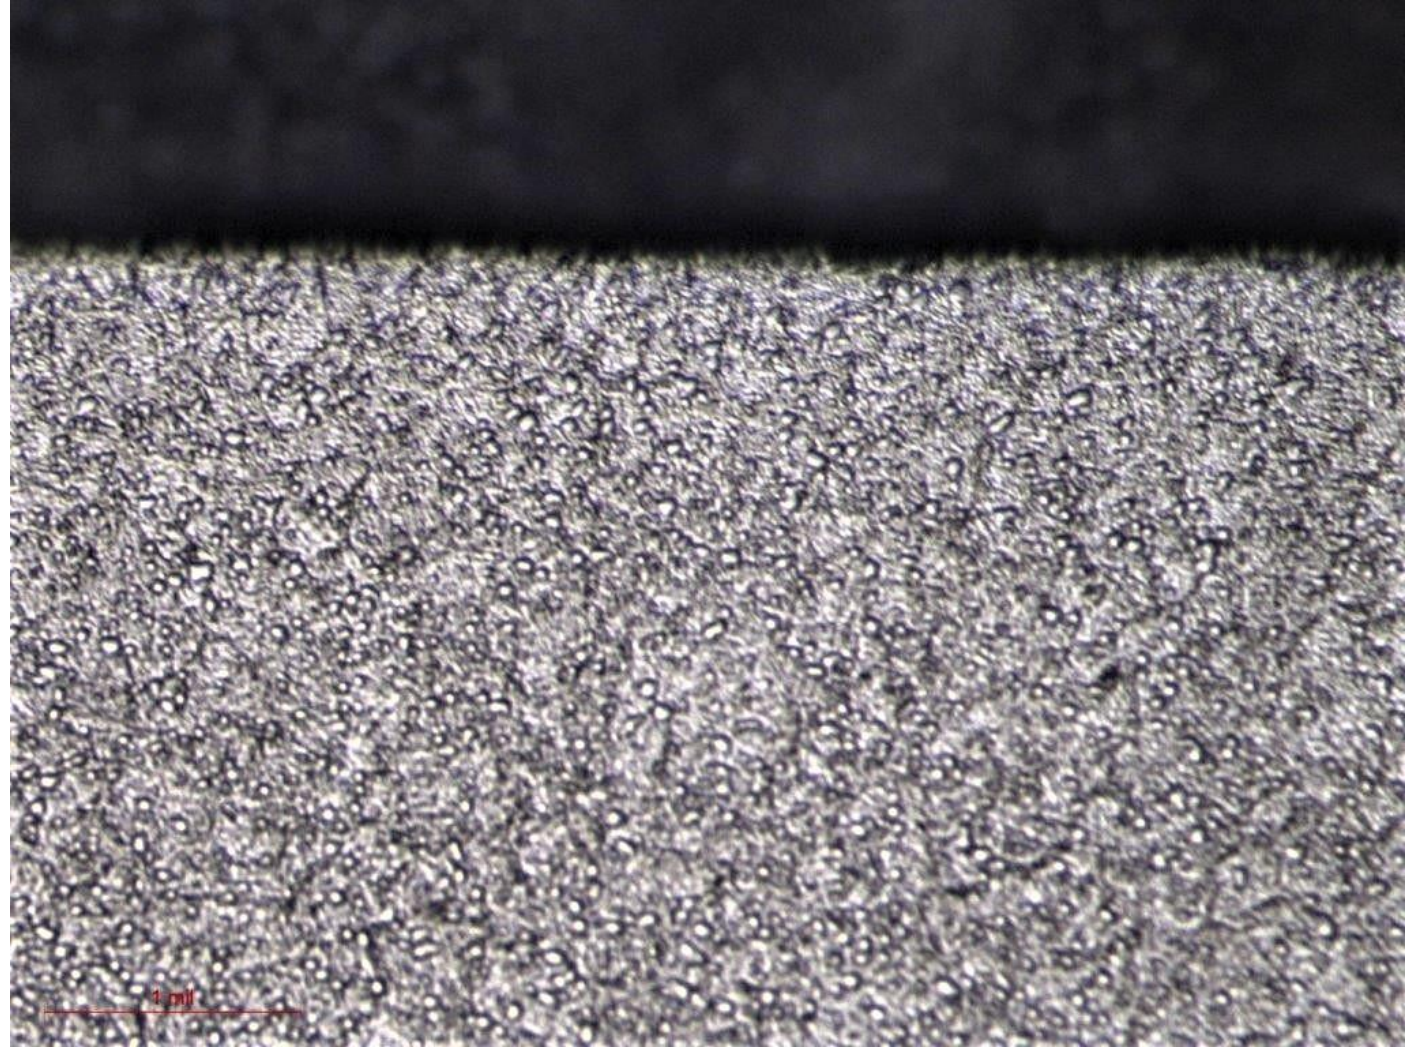
Transverse view at surface
along primary ground bevel.
1000X Vilella's Etch

- Uniform structure along edge
- No evidence of thermal damage

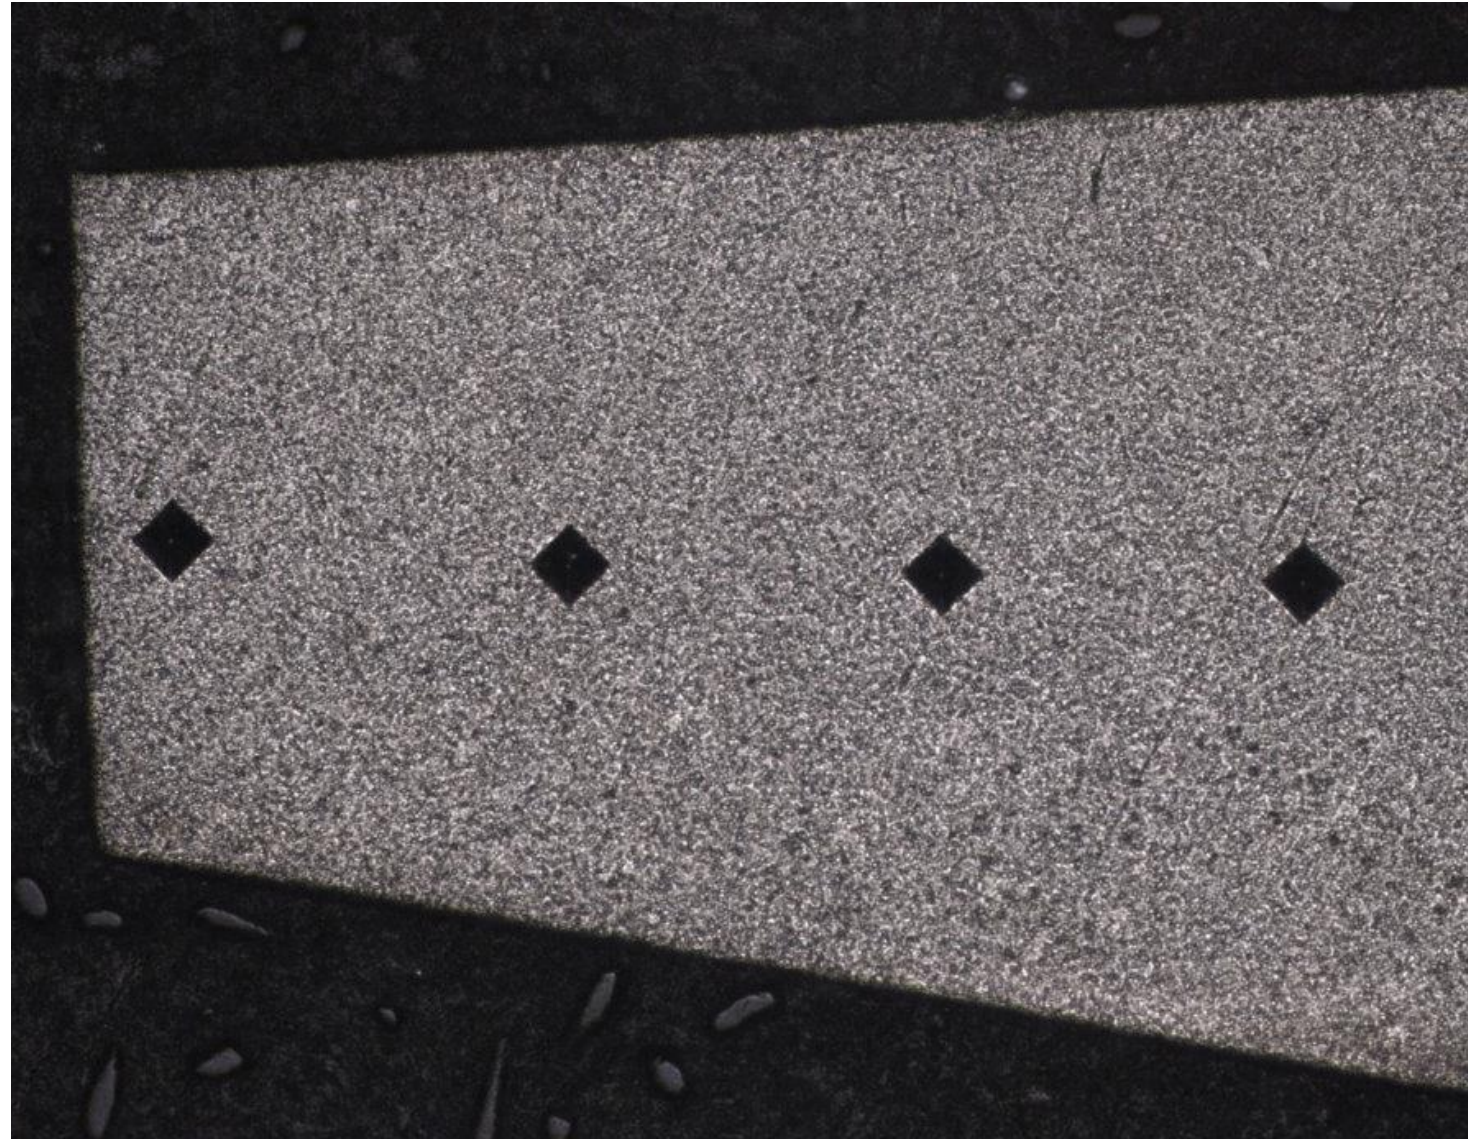
Transverse view of unfinished
cutting edge
50X Vilella's Etch

- Surface integrity appears very good
- Consistent microhardness found along
blade edge and cross section:
745-779 HV (=RC 61.9-63.2)

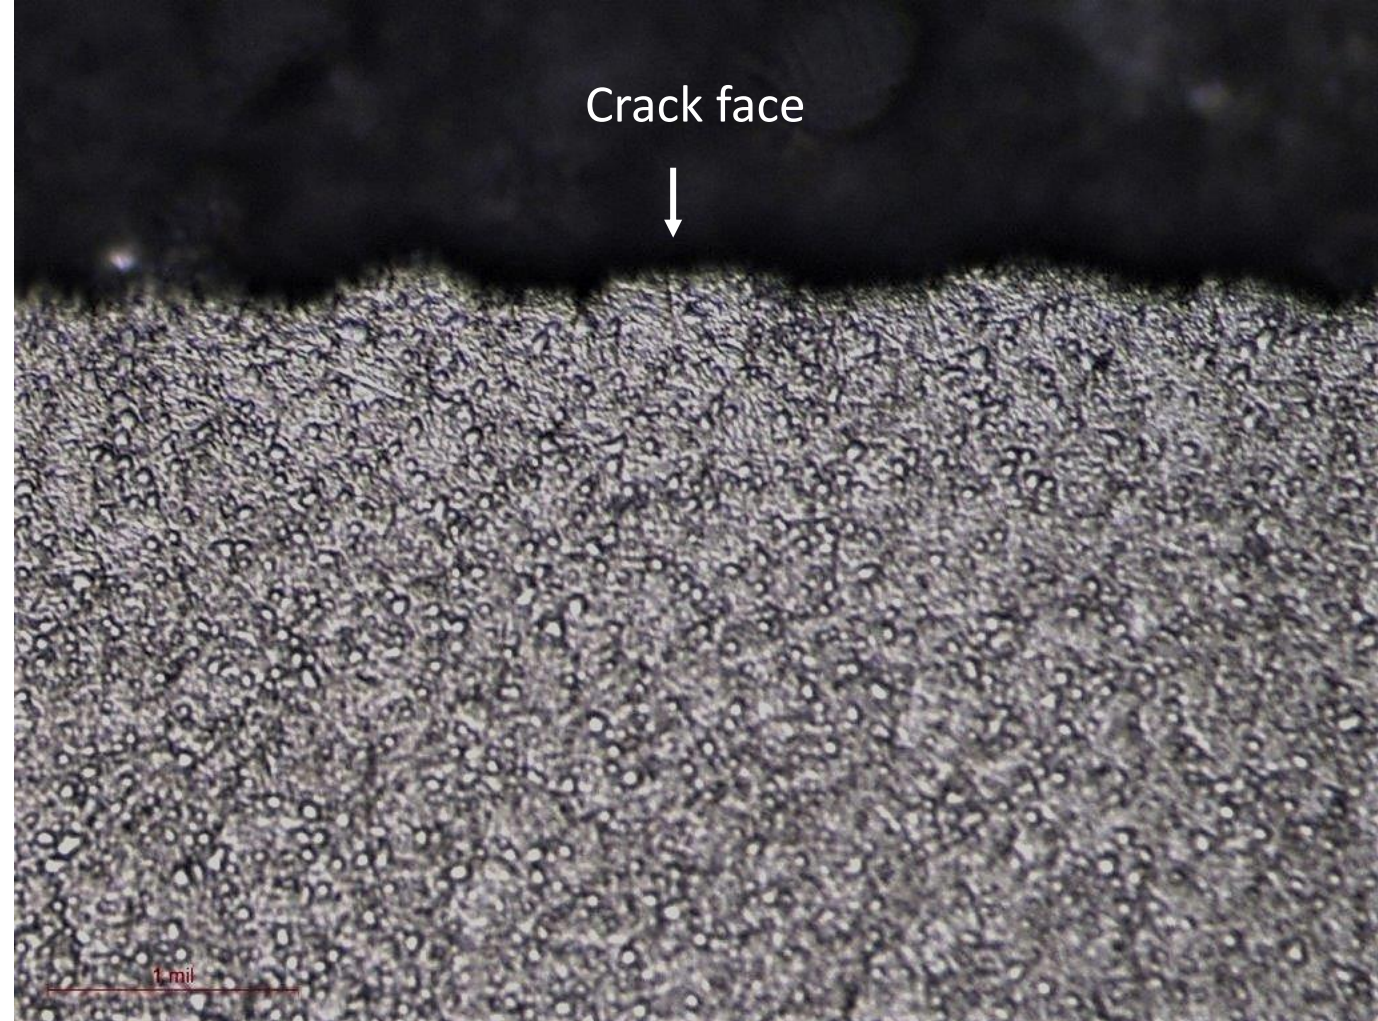
1000X Vilella's Etch

View looking down at edge of crack face

- Fracture appears transgranular in nature with minimal plastic deformation
- Microstructure appears normal along crack face
- Limited ductility evident in fracture behavior is typical given the alloy content and hardness of the blade material

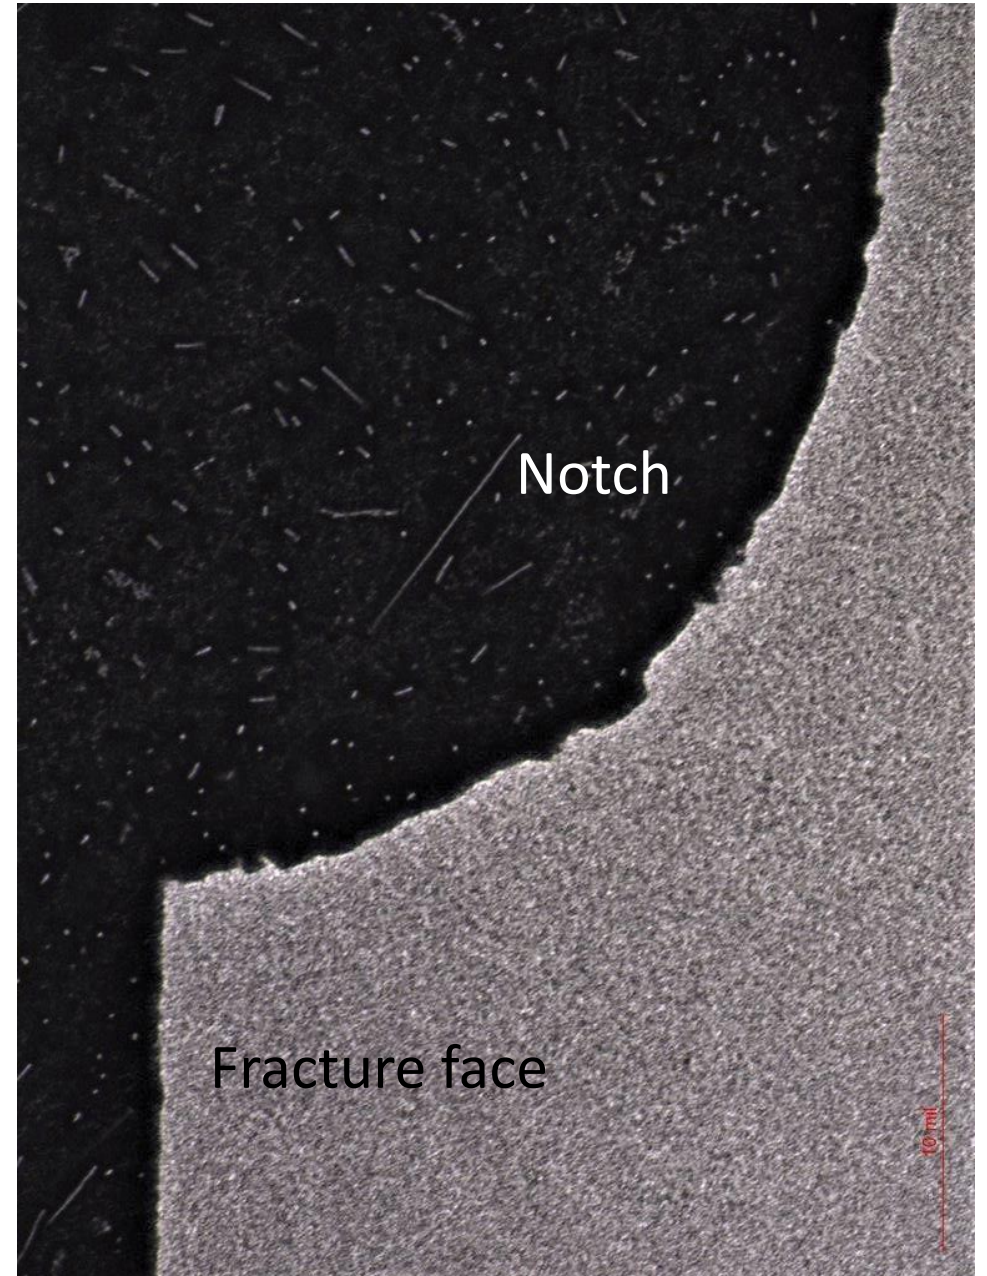
View looking down on jimping
notch/crack intersection
100X Vilella's Etch

- Rough surface noted in jimping
- No evidence of thermal damage

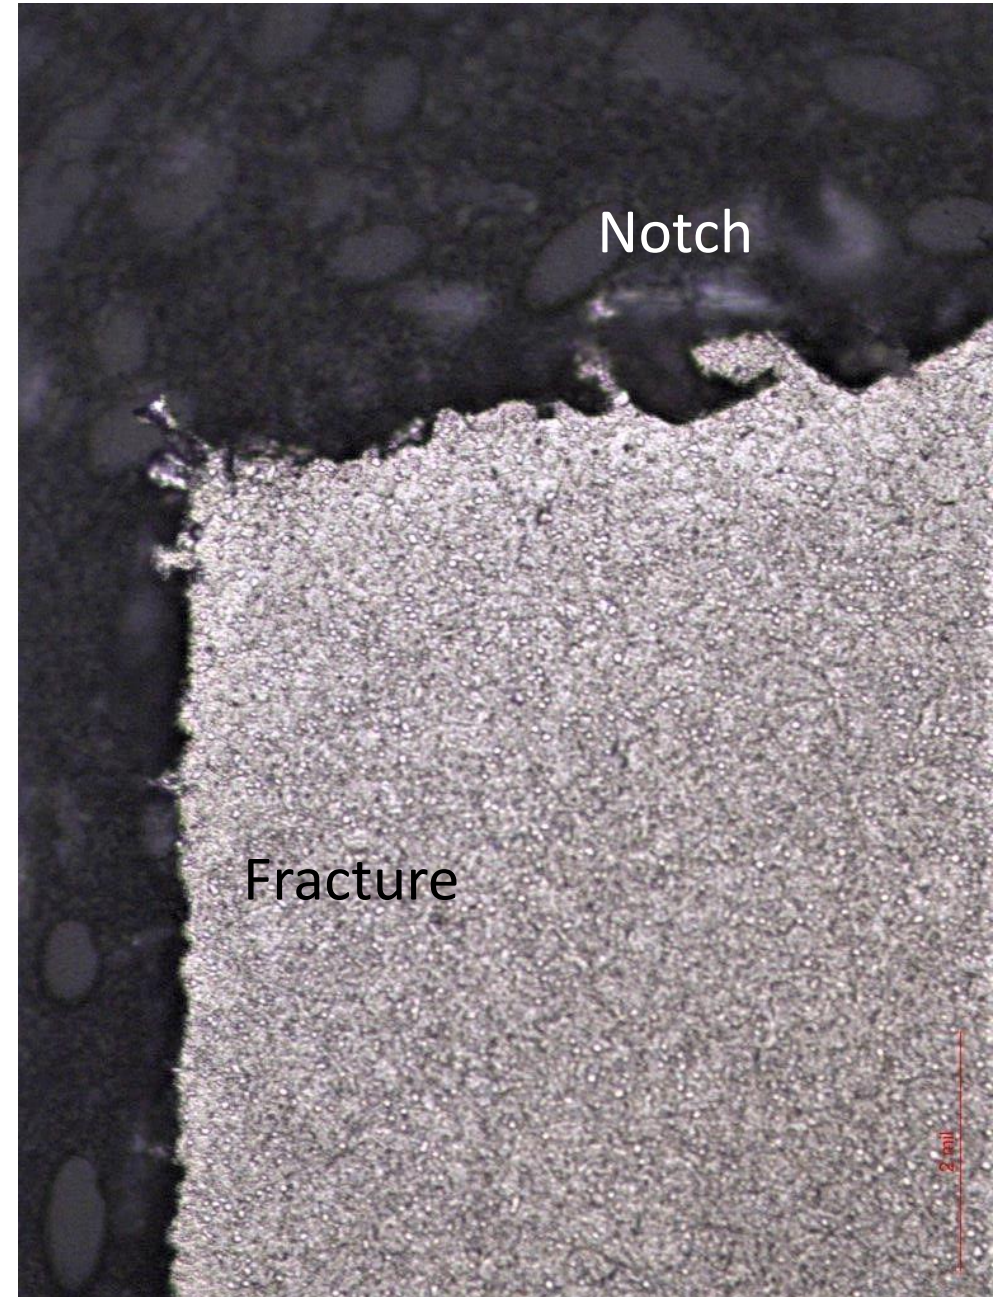
500X Vilella's Etch

Higher mag view of jimping notch/crack intersection

- Rough surface in jimping may have accentuated (stress riser) notch effect
- Microstructure appears normal under surface
